MAIB SAFETY BULLETIN 2/2010

Failure of fixed high expansion foam system to
extinguish fire on board the passenger ferry *Oscar Wilde*

Marine Accident Investigation Branch
Mountbatten House
Grosvenor House
Southampton
SO15 2JU

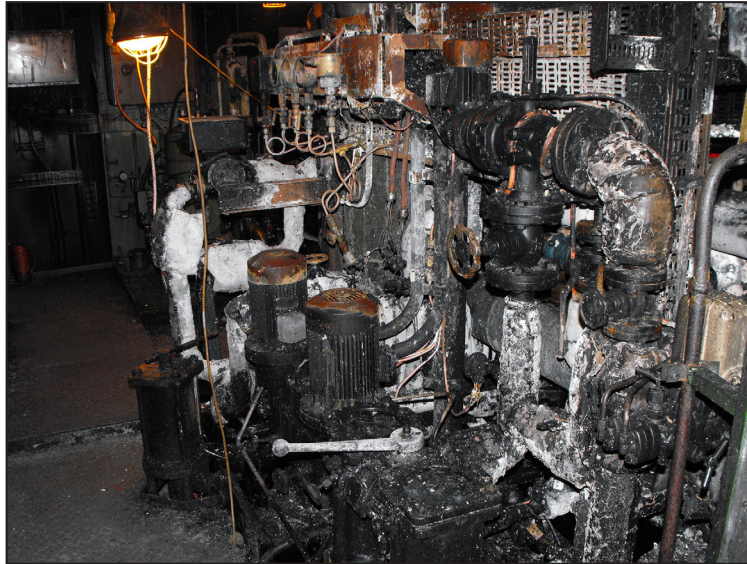
Figure 1

At approximately 1912 (UTC) on 2 February 2010, a fire broke out in the auxiliary machinery space on board the roll-on roll-off cruise ferry *Oscar Wilde*. The ferry had just sailed from Falmouth, UK after completing her annual docking. The seat of the fire was in way of a diesel alternator fuel supply module (**Figure 1**) and quickly spread across the compartment.

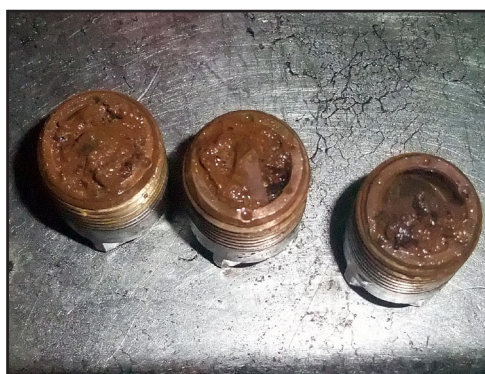
Figure 2

- 80% of the foam generator nozzles within the auxiliary engine room were blocked by debris (**Figure 2**) and about 50% of the nozzles in the other protected spaces on board were also clogged.

The debris found in the nozzles and piping is most likely to have been rust and scale that had built up in sections of pipe in which water and/or foam solution had previously been trapped. This debris would then have been distributed along the pipes and into the nozzles during the annual blow through tests and when the system was operated. The resulting blockages were sufficient to prevent the aspiration of the foam solution.

- Remove and inspect all foam generator nozzles to ensure they are free from debris.
- Inspect sections of distribution piping in which water or foam solution might collect and to fit drains where appropriate.

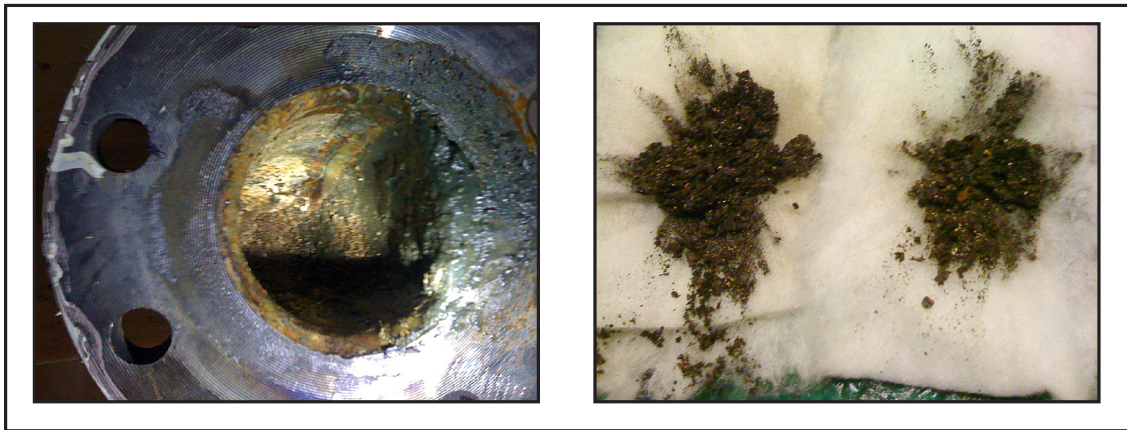
Figure 3

- The distribution pipework for the foam solution contained debris and was corroded (**Figure 3**).

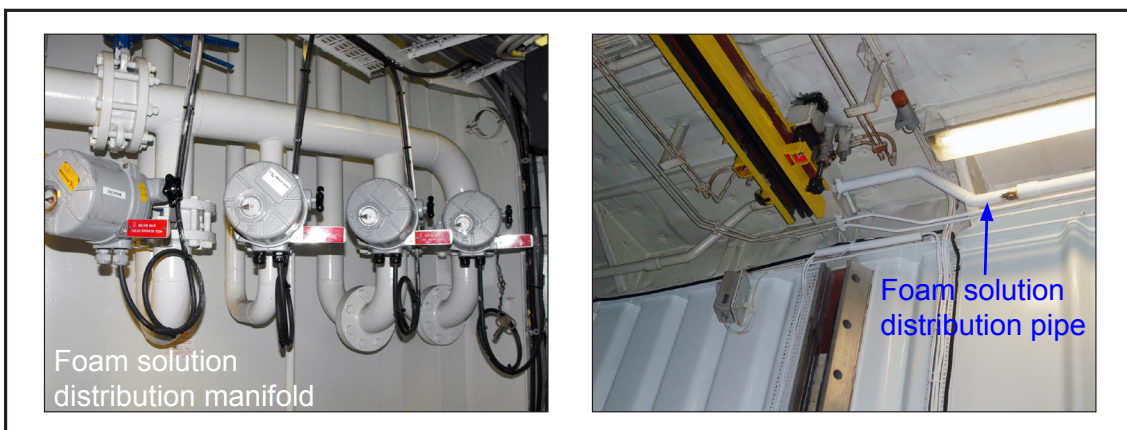
Figure 4

- There were several sections of the system's distribution pipes in which water and/or foam solution could have been trapped following the testing of the system (**Figure 4**).
