## 1 Structural failure of rescue boat

## 2 High potential: spontaneous opening of Hydraulic Release Shackle (HRS) pin

**3 NTSB: Diesel Generator Engine Failure**

## 4 LTI: fall from height during anchor chain handling operation

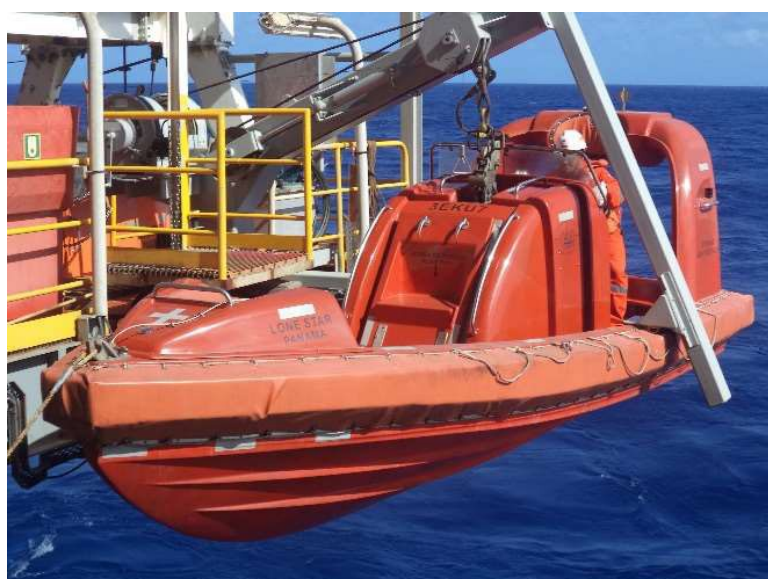
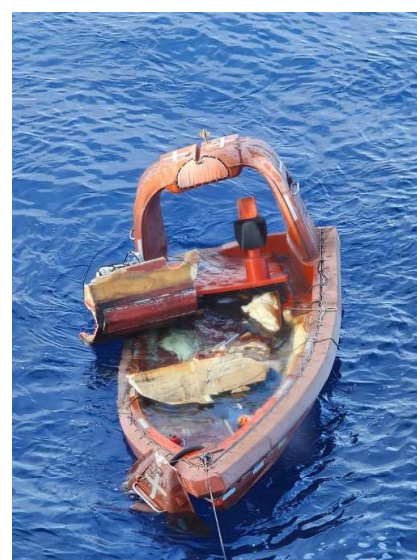
A rescue boat suffered a catastrophic structural failure whilst unattended on the davit. Whilst no activities were being performed by crew on the rescue boat station, the structure of the boat failed causing the lifting frame and the console assembly to be torn off the hull. The hull then dropped into the sea. The remains of the rescue boat were retrieved for further investigation. There were no injuries.

- Forces applied to the fall wire were either equal to or greater than a 1.1 x overload test, as observed on the shock absorber displacement during factory acceptance testing of the boat;
- There were signs that the hydraulic cylinder (shock absorber) was being over-compressed;
- The accumulator of the hydraulic cylinder (shock absorber) was found to be pre-charged with a pressure above that used during the factory acceptance testing of the boat;
- The operations manual provided did not make it clear enough that manual cranking of the davit could cause a possible overload of the load-bearing structure of the rescue boat;

- It was possible for an average crew person to apply sufficient force to the manual cranking handle as to overload and collapse the load-bearing structure of the rescue boat.

Constant excessive force applied to the lifting frame of the boat, eventually led to the lifting frame and the console assembly being torn off the hull. There was constant excessive force applied to the lifting frame of the boat because the shock absorber was unable to absorb the forces caused by excessive manual hand cranking. This happened because:

- The operations manual did not make it clear that it was possible to overload the boat lifting frame by hand cranking the davit;
- The crank lever system available had no means of monitoring or controlling the loads being applied;
- The ongoing damage to the boat and its lifting structure had not been spotted by OEM yearly inspections;
- The shock absorber hydraulic cylinder (shock absorber) was not properly maintained;
- The method of stowing the fast rescue boat not using a cradle but pulling the boat structure against the vertical stoppers increased the likelihood of severe structural damage.

- A technical alert was issued to the fleet and all similar rescue boats were duly inspected;
- The hand crank assembly was replaced by a torque wrench, which permitted some control of the hand cranking forces applied to the rescue boat;
- The stopper on the davit was modified;
- Improved site acceptance and on-site assessment when installing equipment from an OEM, including thorough toolbox meetings between vessel engineers and third-party (OEM) representatives on site;

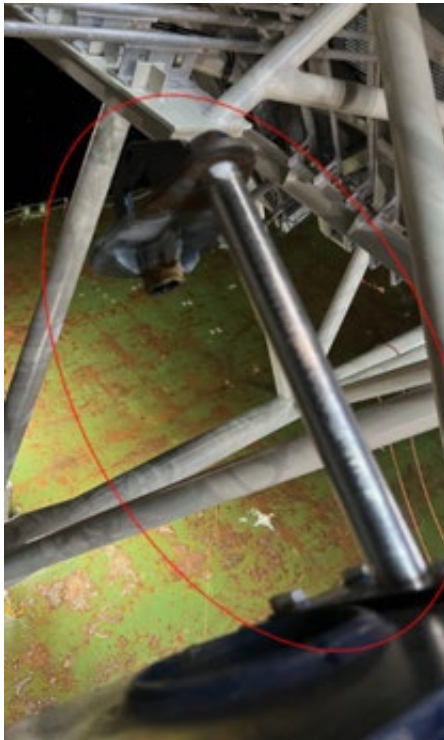
*Broken connection*

After rigging back the 'blue shackle' to its position and performing function tests to this same shackle and the other 3 HRS units, it was then identified that the 'yellow colour coded' HRS was damaged (broken piston) and further damage was identified to the initial 'blue colour coded' HRS (bent piston rod). The operation was subsequently abandoned.

- Ensure all decisions made regarding changes to critical equipment set up are conducted in line with manufacturer requirements;
- Conduct general review for similar equipment across projects and worksites.

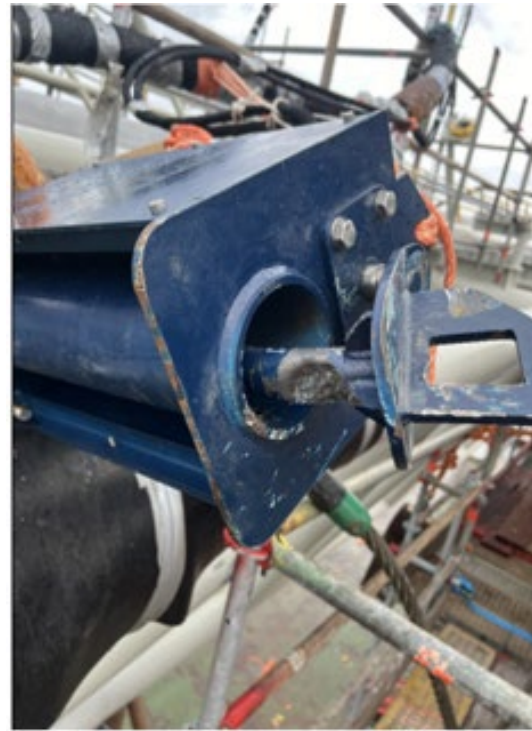
*Bent connection plate*

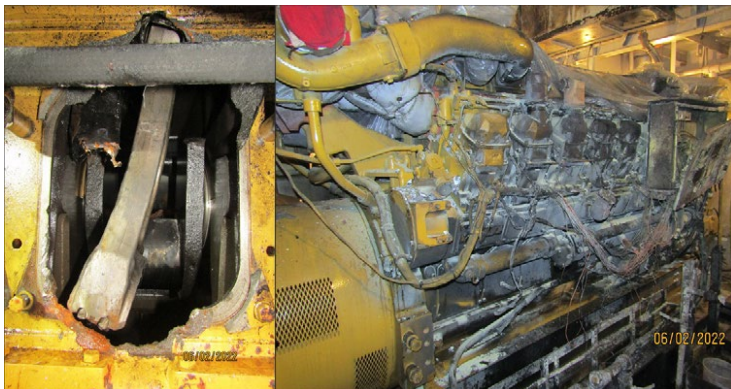
*Damage to crankcase and connecting rod of no. 3 main engine*

After maintenance was completed, sea trials were scheduled to test and ensure the proper operation of the vessel's engines, propulsion systems, and automatic power management system. During the tests, with the two stern thrusters about 75% load, and the no. 3 main engine about 30% load, the engineering crew in the ECR heard a "large bang" and observed smoke in the engine room. No. 3 main engine experienced a catastrophic mechanical failure. The no. 6 main bearing's incorrect size allowed lube oil to leak from the larger clearances of the bearing in the no. 3 main engine, thus decreasing the lube oil supply pressure to the adjacent nos. 9 and 10 connecting rod journal bearings. The loss of lube oil supply pressure resulted in a rapid temperature increase of the connecting bearings and subsequent fracturing of the bearing cap bolts on the nos. 9 and 10 connecting rods. As a result, several engine components broke free while the engine was running. These components were strewn about the crankcase, blew open the inspection cover and part of the engine block, and allowed hot oil and gas to start a fire in the engine room.

Investigation revealed that the probable cause of the mechanical failure of the no. 3 main engine and resulting fire was the replacement of a crankshaft main bearing with an incorrectly sized bearing during a previous engine overhaul. Engine service technicians did not correctly identify the removed bearing's part number, which resulted in the loss of lube oil pressure in adjacent connecting rod bearings.

When maintenance is performed, correct replacement of machinery components is critical to ensuring safe and reliable vessel operation. Vessel crews and equipment manufacturer technicians should carefully identify and document part numbers of all components removed from shipboard equipment. Tracking systems are an effective form of record-keeping that can be used to ensure proper replacement part selection for reinstallation.

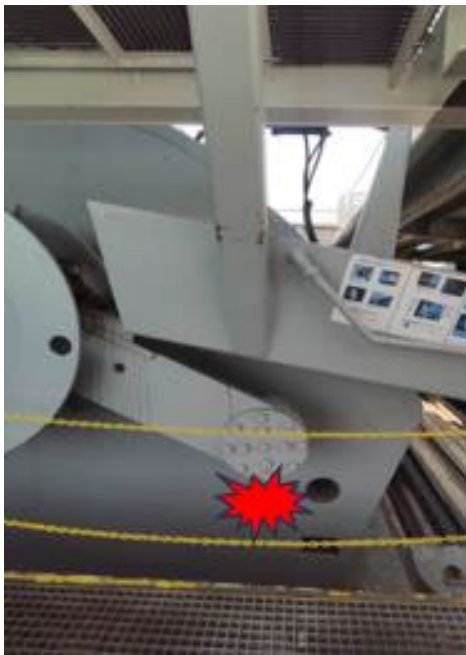
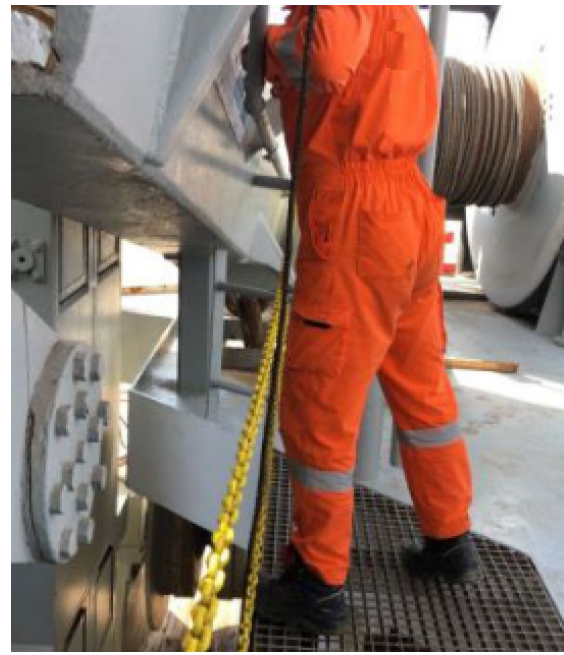
*"A" deck – the place from which the bosun fell, illustrating the chain he potentially stepped on*

According to the CCTV footage reviewed, the bosun put one foot on the chain barrier while passing the wire over. However, as he attempted to move his second leg, he fell through an opening between two chain barriers and landed 2.75m below on the main deck. First aid was administered onboard, and a vessel doctor called for further assessment. The bosun was subsequently transferred to shore for further medical evaluation. He suffered multiple fractures to his right leg and broke a rib.

- The injured person placed his foot on an unstable surface (the chain barrier), which led to the fall;
- There was a lack of proper planning and risk assessment: The specific activities involved were not covered under the anchor handling risk assessment, meaning important considerations, such as safe access to the chain road, were not properly evaluated;
- There was a lack of focus and hazard perception: The potential risk of falling while stepping over an unstable chain was not understood.

- Greater care when accessing locations at height – only correct, proper, secure, stable, and purpose-designed platforms and equipment should be used;
- Better identify potential fall hazards, particularly in areas with open spaces, such as around chain barriers;

- A more thorough and detailed risk assessment should be made for each step of the operation, thoroughly evaluating all associated risks. All identified hazards and corresponding control measures should be clearly communicated to the crew and verified to be in place before starting work;
- Better supervision of high risk tasks, particularly when working at height.

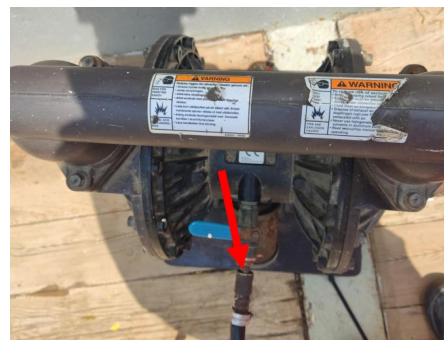
- There was no secondary securing system – no whip check arrestor – installed, even though this was specified in the task risk assessment;
- No-one checked the equipment before starting the job;
- No-one stopped the job;
- The hose end coupling itself appeared as worn out, and this was unnoticed;
- There were no whip arrestors and hose tail couplings available, neither on the vessel or with the contractor doing the work.

*Disconnected hose end connection*

- Ensure there is sufficient equipment and spares on board to do a safe job – the lack of even a very small part can lead to something being unsafe;
- Ensure pressurised hose connectors have secondary securing – whip arrestors;
- Check your equipment before you start work – it only takes a few seconds. Check the condition of hose end couplings on pressurized equipment, and identify any wear or damage that could compromise their integrity during usage.
