1 LTI: Finger injury during emergency recovery of ROV

2 BSEE: recurring hand injuries from alternative cutting devices

3 Hot work performed outside of Permit to Work (PTW) boundary limit

5 NTSB: Crane wire failure

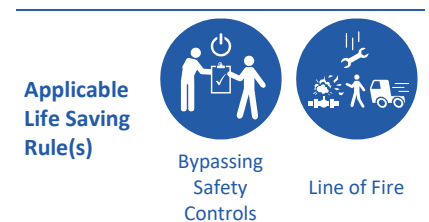
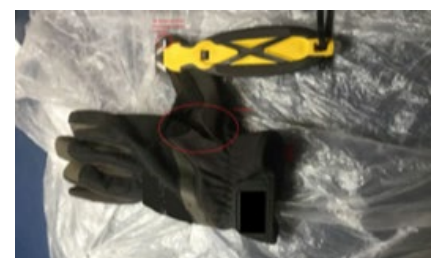
Incident 1: While running a new cable in a cable tray, an offshore worker was using a cutter to remove previously installed zip ties. Although the protective tip of the cutter was damaged, exposing the blade, the offshore worker continued to use the damaged cutting device. The exposed blade cut through the worker's glove, causing a laceration on the left hand between the thumb and index finger.

Incident 1: Damaged alternative cutting device and cut glove

- Ensuring all personnel identify the appropriate alternative cutting device in the Job Safety Analysis for the assigned task;
- Inspecting the alternative cutting device before use to confirm that the protective shielding is free from wear or chips and that it is properly installed;
- Ensuring personnel do not alter or modify alternative cutting devices before use;
- Ensuring personnel use cut resistant gloves for added protection when using alternative cutting devices;
- Ensuring that if the alternative cutting device is defective in any way, the cutting device is discarded appropriately.

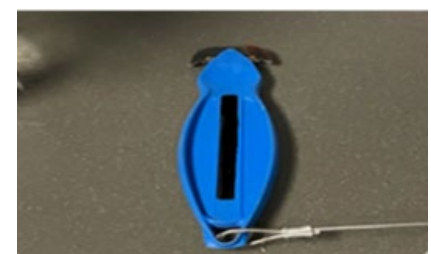
Incident 2: An offshore worker sustained a laceration to the back of their hand, between the thumb and index finger, while cutting zip ties. The incident occurred when the cutting device rebounded, causing the injury. It was found that the protective guard over the blade was missing, leaving the blade exposed (Figure 2).

Incident 2: Exposed blade on alternative cutting device

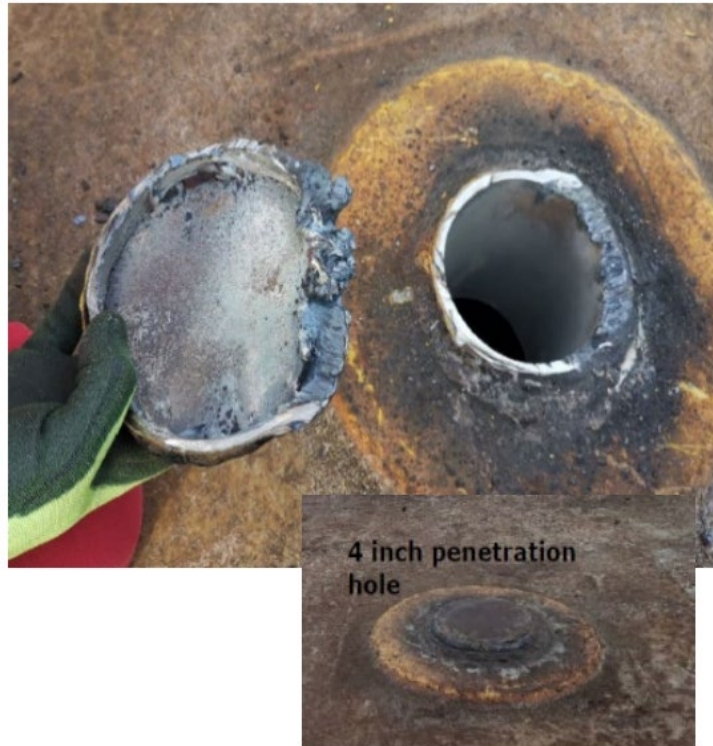
A near miss occurred when a third-party contractor working onboard a vessel removed a trip hazard (a metal stump section) from the vessel main deck, using a cutting torch and grinding disc. Whilst cutting the 10cm diameter stump, sparks and slag (hot work discharge) dropped into the hole in the deck and fell to a thruster room directly below, onto scaffolding boards and onto a 600V HV electrical cable. There were some burn and scuff marks caused. Vessel engine room crew in the affected area noticed the falling sparks from above, and further identified that there was no fire watcher available in the vicinity. The job was stopped immediately.

Cut penetration

- Training:
 - Review and update training material to ensure all aspects of the PTW requirements are captured;
 - Ensure third-party contractors receive adequate training (including refresher training) on the Permit to Work system;
- Job preparation:
 - Review and update pre-job planning, hazard identification, job site inspection and readiness plans before issuing a PTW;
 - Ensure all crew involved are properly informed and updated about any Permits to Work in operation;
 - Review Task Risk Assessment to capture the lessons learned of the incident;
- Ensure adequate supervision available at site;
- **STOP!** remind each other that procedures and processes are there to help us.

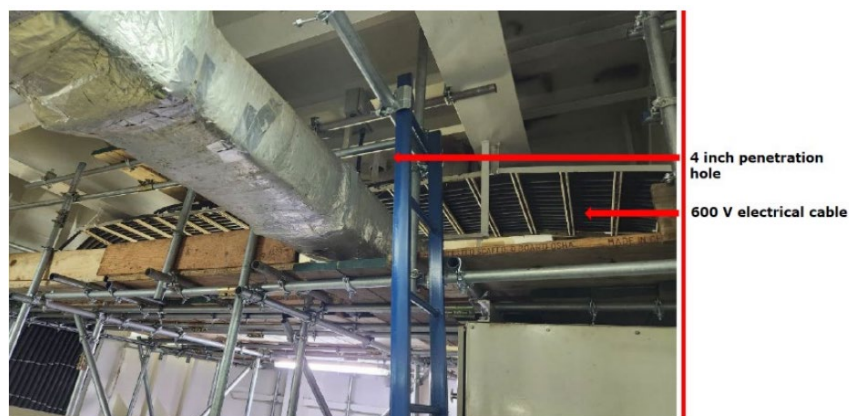
View from area below the deck

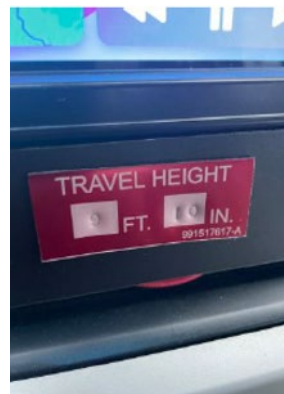
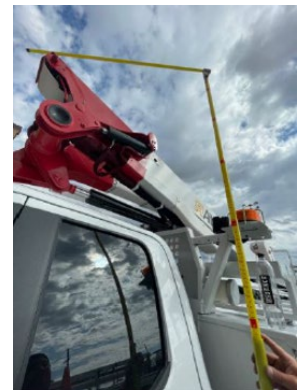
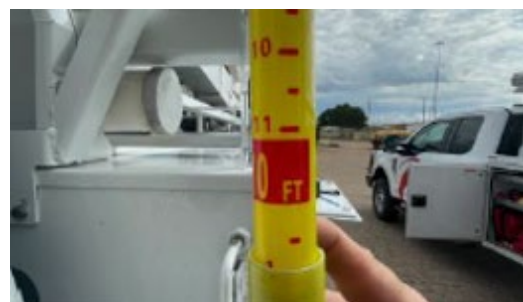
On investigation, it was found that the stamped traveling height on the truck was different from the actual traveling height. The actual traveling height was verified by careful measurement. The truck was stamped with a traveling height of 9 feet and 10 inches (300 cm) but the actual measured traveling height was found to be 10 feet 1 inch (307cm).

- Whilst this incident is about vehicles, the principle applies not only to all industrial vehicles and sometimes private cars, but in general to safety information that we may have assumed for years is correct.
- Consider checking height of vehicle information in industrial vehicles, overhead clearances and other measurements;
- Consider checking how up to date are any printed manuals or instructions you have.

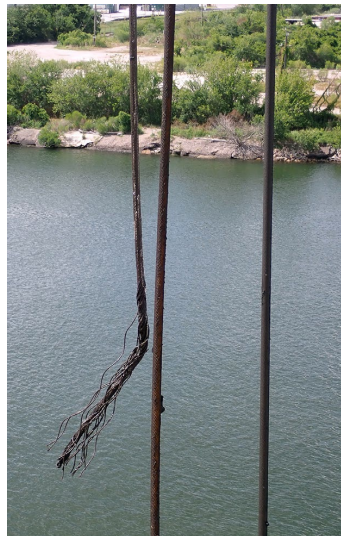
The probable cause of the failure of the hoisting wire was undetected corrosion and wear in strand wires.

Parted wire rope on the crane side

roughness and pitting, and “uniform corrosion of internal surfaces” of the hoisting wire rope. This corrosion and wear caused some of the individual wires comprising the strands of the hoisting wire rope to part when the crane lifted the nacelle unit, subsequently causing the strand and then the remaining wire strands to become overloaded and fail.

- Saltwater and humid ocean air cause corrosion of metals, presenting challenges for the maintenance of high-strength steel wire ropes on vessels. A deteriorated wire rope directly affects a crane’s ability to safely and reliably handle loads up to the crane’s rated capacity (safe working load). Therefore, diligent inspection, maintenance, and management of wire ropes are essential. Working wires should be changed at recommended intervals, or more frequently, depending on operating conditions and use.

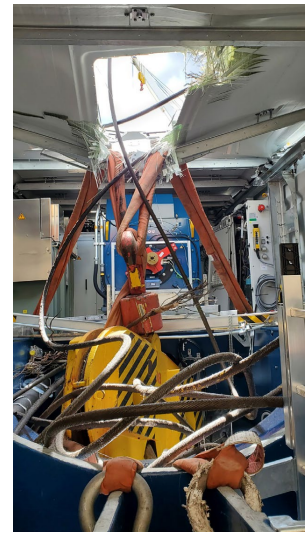
A crane wire on a cargo vessel parted whilst the vessel was offloading a wind turbine nacelle. The nacelle, weighing 69 tonnes, dropped back into the vessel’s cargo hold. There was no pollution nor injury, but damage to the vessel and to the dropped load were estimated at US\$3–5 million.

Crane block smashed into the top of the damaged nacelle
