ALERT 15-02

## EMPLOYEE'S FINGER AMPUTATED

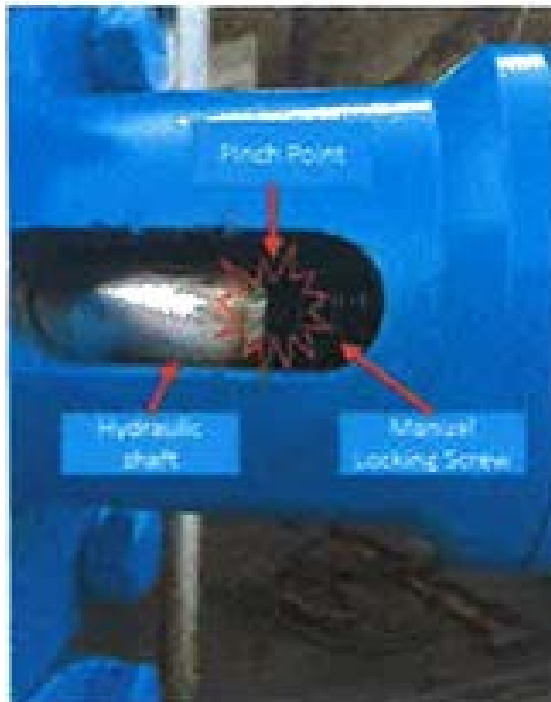
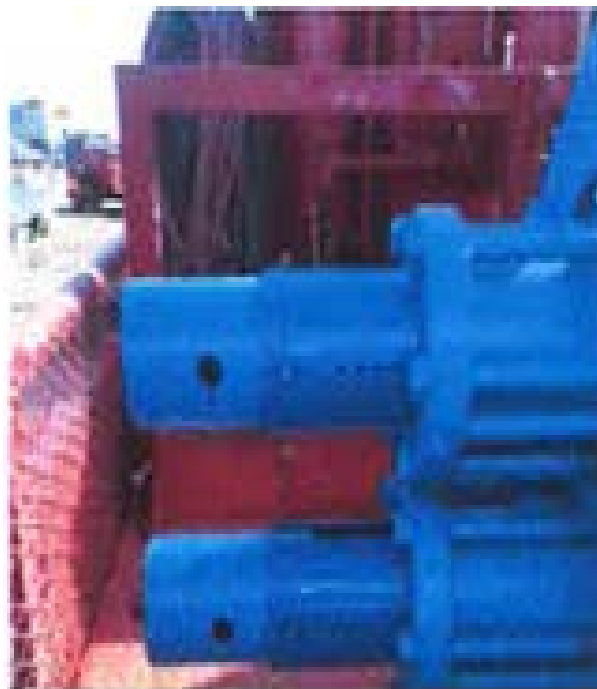
The injured employee was in the process of unlocking the BOP ram in order to open the ram with a hydraulic system that was spotted 50 feet away from the BOP. The employee decided to place his finger into the OEM sight opening slot to make sure the locking screw was completely out. The crew chief engaged the ram control valve while employee's finger was still in the slot resulting in an amputation of the employee's left index finger.

The employee was able to place the finger thru the OEM sight opening on BOP ram shaft bonnet. The control system was not isolated, locked out or tagged out while the IP placed his finger inside. There was no apparent understanding or communication between the IP and the remote operator.

A temporary guard was manufactured and placed over the BOP ram shaft bonnet. The guard will be bolted using the original screw holes on BOP to avoid employees placing their fingers into the shaft compartment. Equipment should be isolated from remote or third party operation before being worked on. Additionally, a thorough JSA should be conducted prior to start to identify hazards and establish communication.
