Marine Safety Forum – Safety Flash 11-32

Issued: 23rd August 2011

Subject: FIRE IN ENGINE ROOM OF OFFSHORE SUPPORT VESSEL

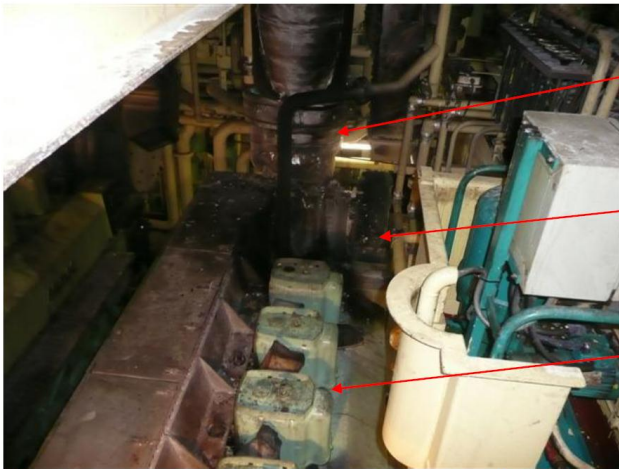
Source of Ignition- Hot Lagging on Exhaust an Turbo-charger-evidence of damage caused by fire

Location of Fuel Injector Pump at end of Engine Block

Overall View of Main Engine No.2 showing location of Fuel Pump and seat of Fire

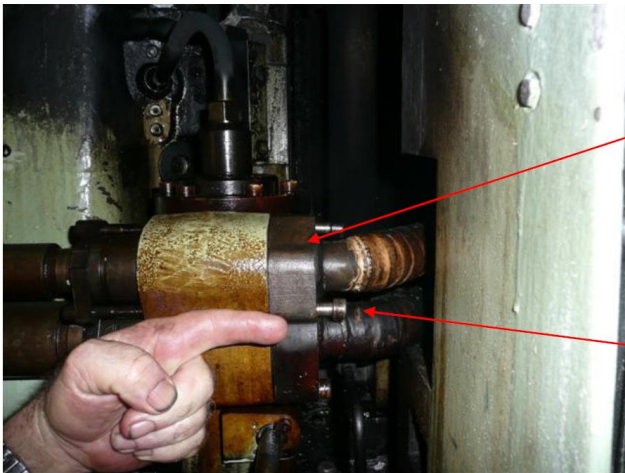
The source of the fire was subsequently identified as due to fuel oil leaking from the flange on a Fuel Injector Pump on main engine No.2. The fuel return line had come loose at the flange due to one of two securing bolts shearing and the other working loose. Fuel sprayed from the leaking flange and impinged upon the adjacent hot lagging of the main engine exhaust and turbo charger resulting in ignition and subsequent fire.

Leaking Flange on Fuel Injector Pump Inlet Line

Flange Securing bolts that failed allowing oil leak to spray under pressure

Fuel Injection Pump Inlet Line showing 2 securing bolts holding flange face of Fuel Injector Pump

- Include 3 monthly checks on fuel line flange bolts into contractor's Planned Maintenance System (PMS). This to include physical checks on the torque and condition of the fuel flange bolts as per Original Equipment Manufacturer (OEM) guidelines.
- Request information from engine manufacturer (MAK) on bolt composition and torquing requirements on securing bolts for the Fuel Injector Pump. Information to be disseminated to vessel operators and marine community via subsequent Information/Safety Flash

- Vessel operators to initiate checks on similar fittings on Fuel Injector Pumps and other high pressure pumps to check on condition and integrity of securing bolts. Checks and monitoring are especially critical after maintenance and reinstatement of high pressure lines to check for steady state operation

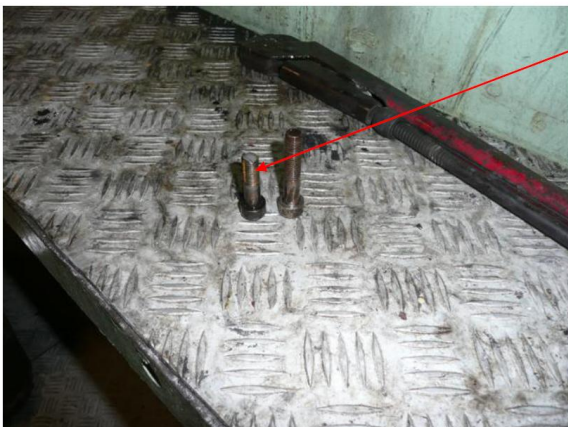
View of one of two Flange Securing Bolts that failed

Close View of Securing Bolts that failed holding flange face of Fuel Injector Pump
