Alert 10(a) -10

**WRONG DIRECTIONS: A RECIPE FOR FAILURE**

Safety Alert 1 of 2

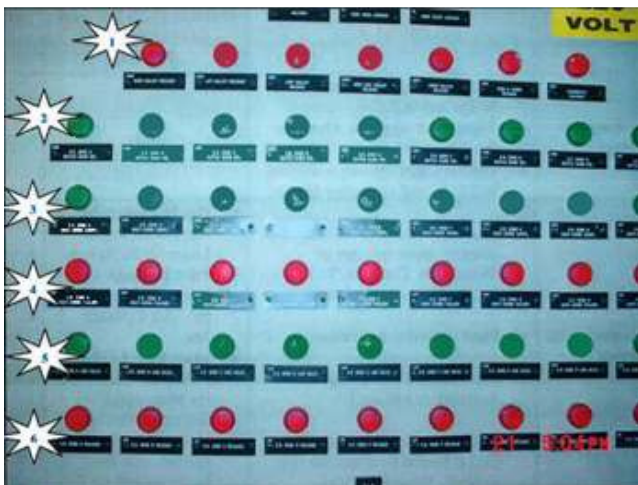
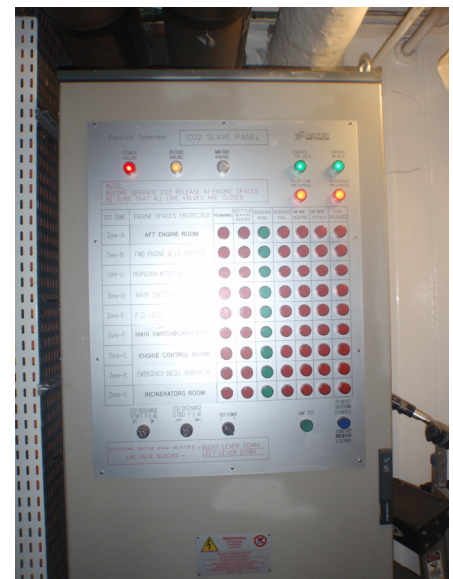
- Shipyard commissioning test procedures appear to differ from procedures documented in the vessel’s Firefighting Instruction Manual (FIM). Commissioning procedures indicate that the discharge line selection to a specific protected zone should be made prior to releasing the gas contrary to the directions in the FIM.
- The FIM refers extensively to a Control Panel (left following image) that differs vastly from the one onboard the vessel (right following image).

- Ensure that all supporting documentation, piping schematics, plans, manuals, component labeling and instructions are consistent with each other and relevant to the systems, equipment, and components installed onboard the vessel.
