Marine Safety Forum – Safety Flash 10/23

Subject: High Potential Incident Following Failure of Home Made Equipment

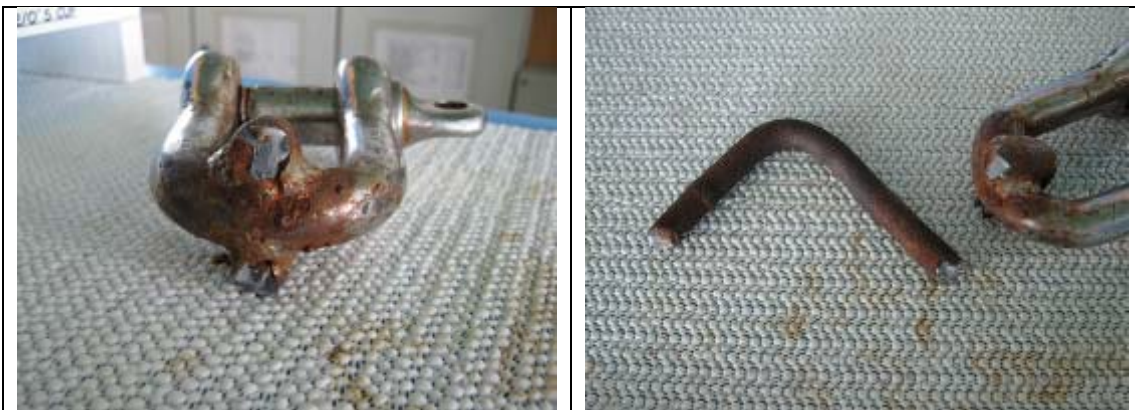
A supply vessel was instructed to return to port due to poor weather conditions at the field. The Captain instructed the deck crew to ensure the containers on deck were adequately secured using chain lashings. The chain lashings were put in place and the decision taken by the deck crew to use the tugger winch to tighten the lashings. When the tugger was tensioned up the chain lashing parted and a piece of flying debris struck and broke the bridge centre aft window. The investigation found that a home chain connection (a piece of chain welded to a stainless steel shackle) had at some stage been introduced into the cargo lashing system. This was probably done so the tugger wire hook could be quickly connected. Being home made it was not certificated and there was no way of knowing its breaking load. We do not like the expression but this was an accident waiting to happen. The deck crew are extremely fortunate not to have been killed or seriously injured.

- The main and overriding lesson from this incident is that home made equipment or tools can never be tested or certified appropriately and often fail sometimes with serious effects. They should never be made or used;
- Home made tools are often made for expediency. However almost always a proper tool or piece of equipment can be sourced from an appropriate supplier. In this case the ship could have requested an enlarged link and connector;
- When using a winch all parts of system being used (shackles, chains, wires, slings, etc.) must have a breaking load higher than the force the winch can exert and certificates to prove it;
