IMCA High-Value Wire Ropes in the New Offshore Environment – Report 2024

Lifting & Rigging Seminar
12 September 2024

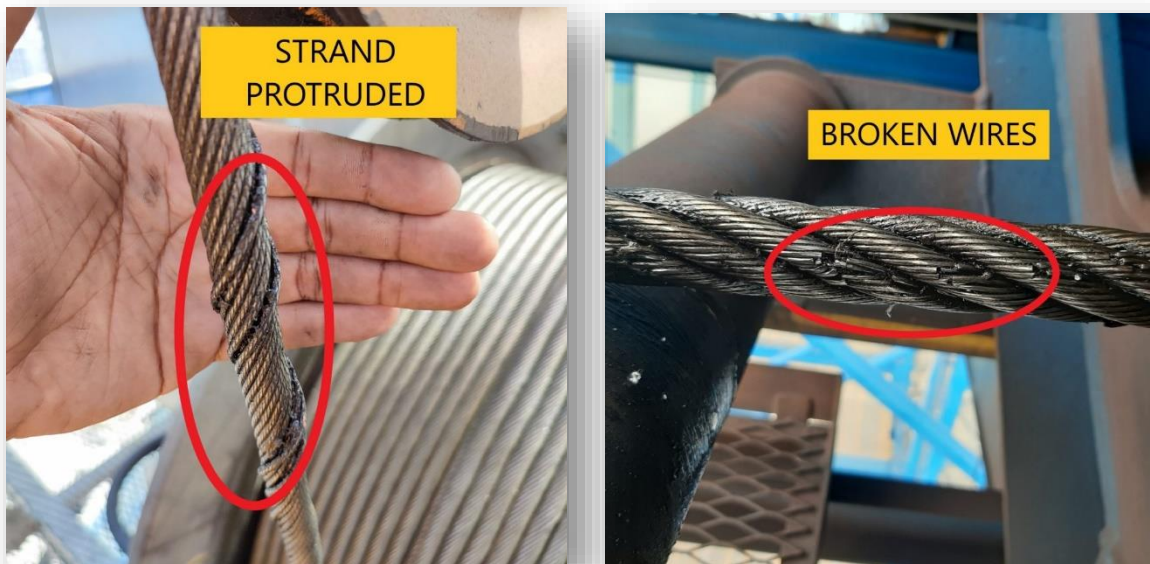
To close the presentation, a few photographs of wire rope in different failure modes were shown as follows:

Figures 7 – Example Wire Rope Failure Modes

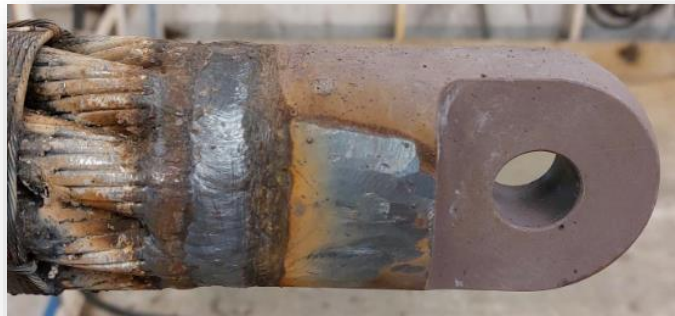
Yoeri stressed that installing a new rope with back tension was important. It improved the spooling, reduced crushing damage and reduced the risk of knifing or cutting in. He said that there were obvious risks and challenges associated with back tension installation, such as reel strength, and that it required a large line pull force to install. The use of a proper pullhead was mentioned. It was noted that a pulling head process and guidance on safely fixing the pullhead was a potential subject for IMCA to address.

Figure 13 – Pullhead

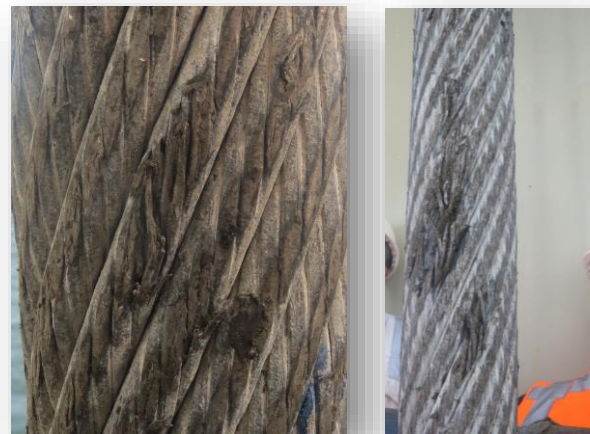
The first case study concerning the Bokalift 1 was for the 1,200t auxiliary hoist. The wire rope was commissioned in November 2017 and was discarded due to damage in October 2018. There was evidence of mechanical damage on the outside of the rope, which was not linked to the cross-over area when spooling. The damage was evident in the 6th and 7th layers of an 8-layer drum. It was said that the damage was potentially caused by layer-to-layer crushing and possibly enhanced by the dynamics experienced during installation.

Figure 15 – Damage of the auxiliary hoist rope

Jack said there was no clear conclusion on the cause of the damage. No cut in the drum layers was reported. The remedy was to change the wire rope for a new one and carry out wire rope training post-installation.

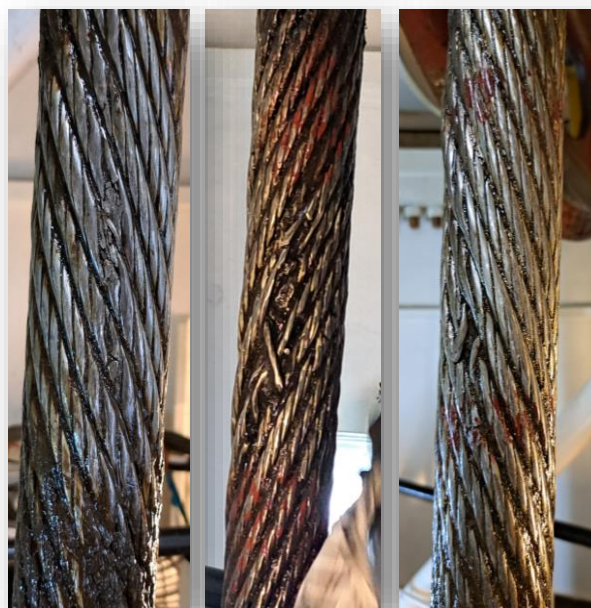
There was visible outside damage and multiple broken strands. The cause was attributed to wire rope cut-in on the drum.

Figure 16 – Damage to the auxiliary hoist rope

The remedy to prevent the cut-in on the drum was to increase the pre-tension in the lower layers. The wire was also changed to non-rotating and was of a slightly larger diameter than specified by the manufacturer. The rope was then trained post-installation.

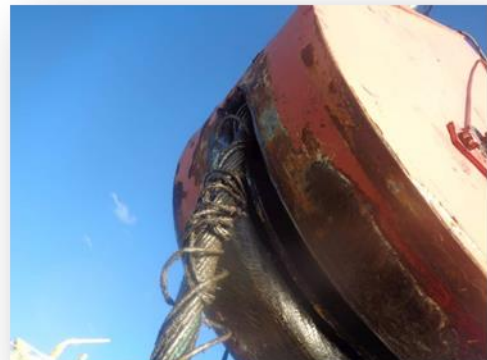
Marco then moved on to another case study involving a 3,993-tonne WLL crane lifting a module of 3,600 tonnes. The main hoist wire rope failed during the lift, and the module dropped to the seabed. Upon investigation, it was found that the wire rope suffered unknown internal corrosion, which led to the failure.

Figure 18 – Crane and rope failure

Marco stressed that using a robust wire integrity management system would have more than likely prevented the failure of the wire rope.

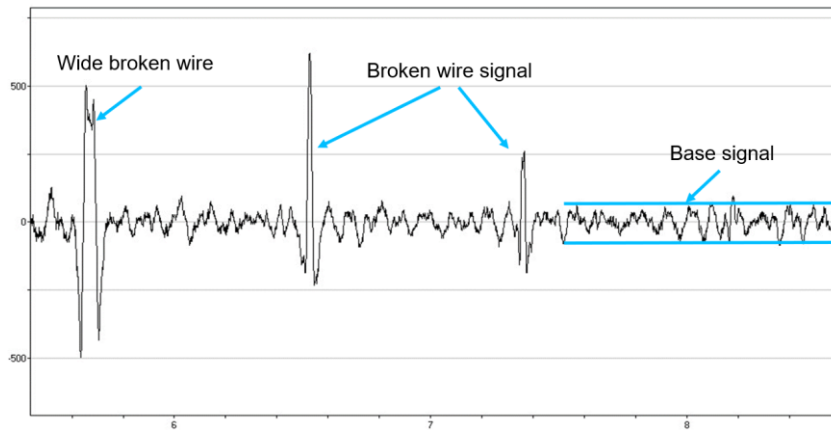
The actual wire break signal was then presented, and it was clear that the signal depended on the cross-sectional area ratio and the length of the wire break.

Figure 26 – Form of wire break signals (real)

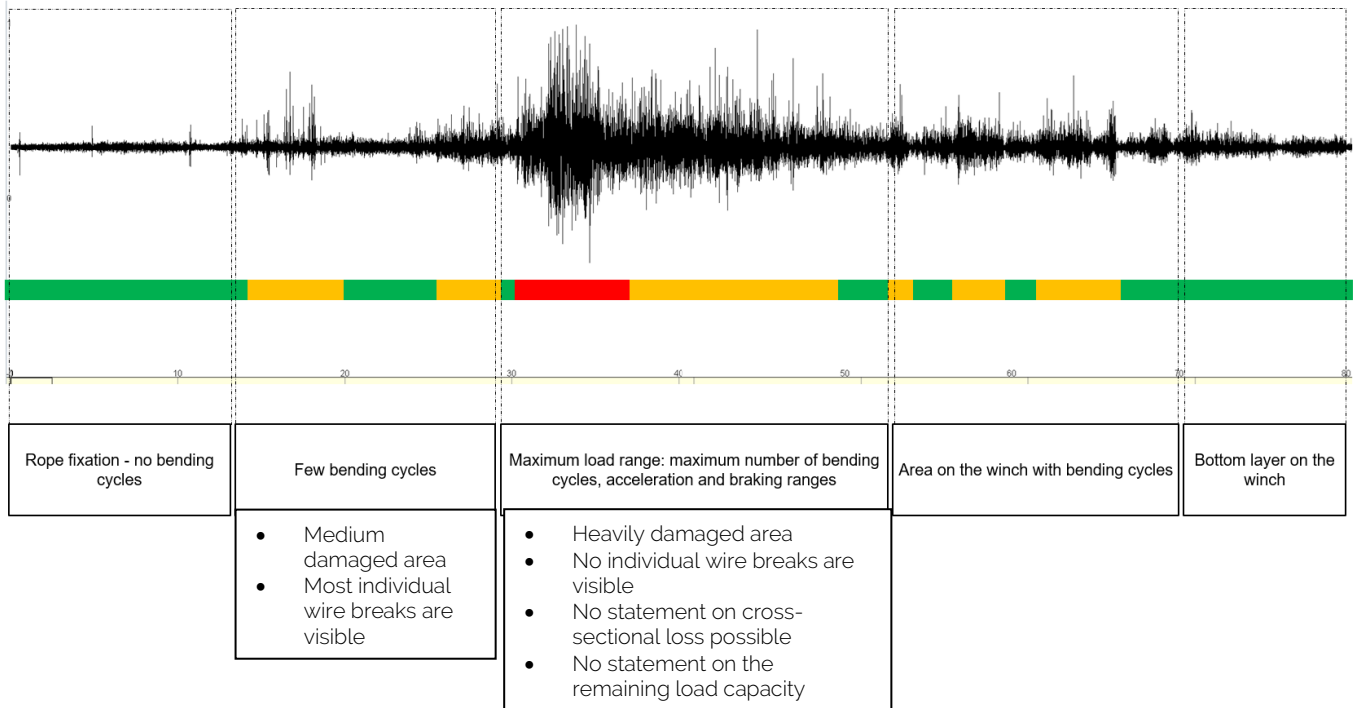
An example of a discarded rope from a storage retrieval system was shown as follows:

Figure 27 – Example of a discarded rope from a storage retrieval system

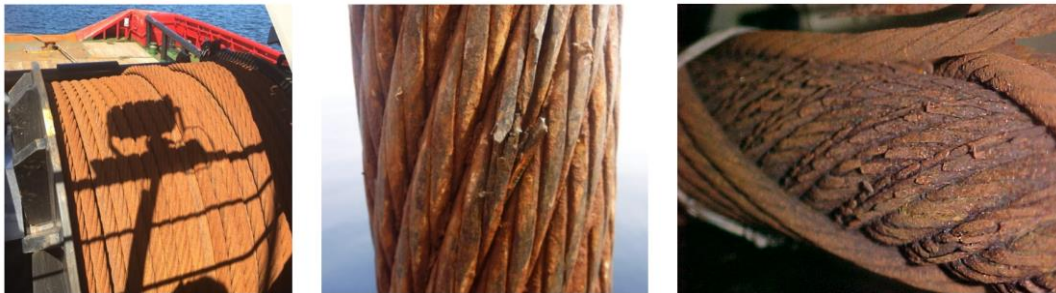
The worst case was shown, which was no grease (and no maintenance). Of course, it was eco-friendly, but there was severe corrosion.

Figure 29 – No grease

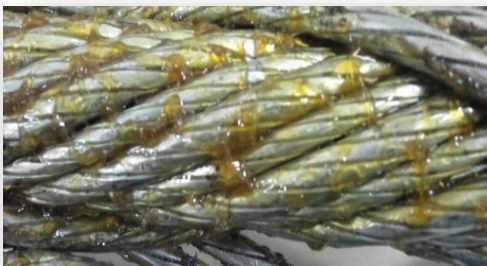
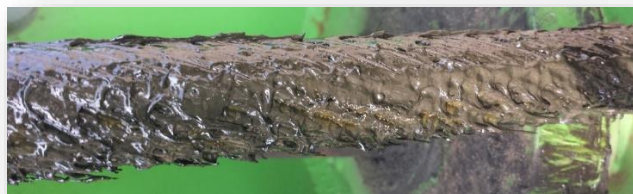
The following slide showed an example of early-stage bio-grease and the wrong lubrication technique. This was followed by an image showing excess grease with obvious safety, operational and environmental issues.

Figure 30 – Bio-grease / wrong lubrication & excess lubrication

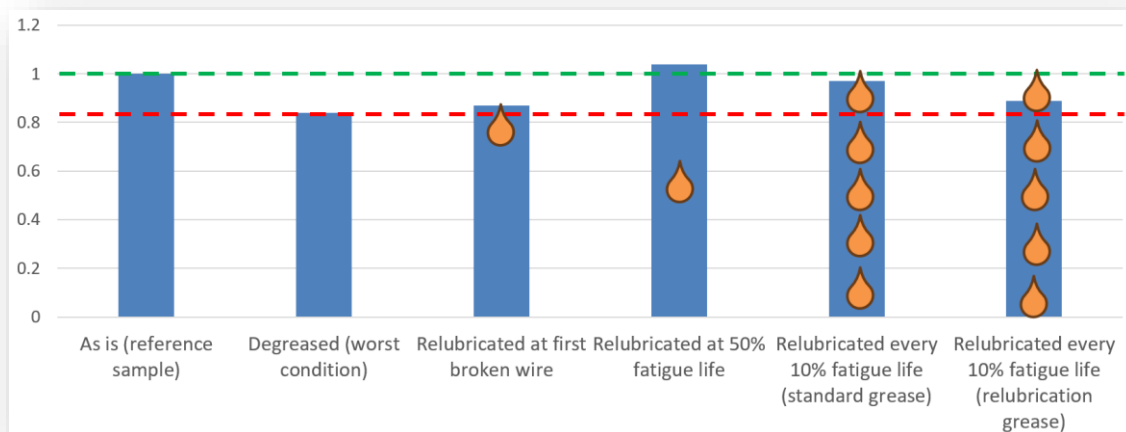
Figure 31 – Summary of the results.

Laura then presented various tests that had been carried out on lubricated and degreased ropes. It was evident that a thoroughly degreased rope showed a 17% reduction in the number of bending cycles before discard compared to a new one. Additionally, if the rope was re-lubricated after the first wire break had been identified, then there was a 13% reduction in the number of bending cycles before discarding it compared to when it was new.

The results are summarised as follows:

It was stated that preserving the native rope lubrication was essential for better service life.

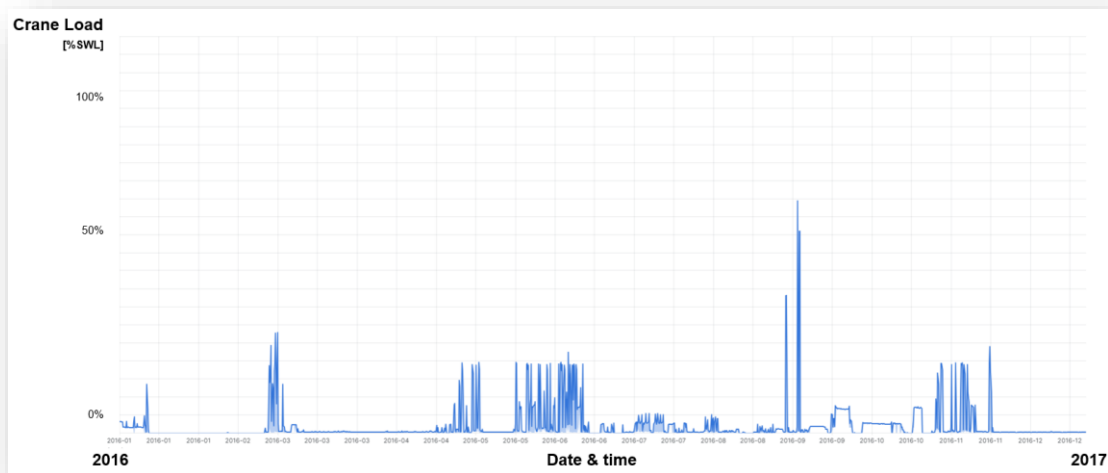
Figure 45 – Crane working in oil and gas

This was clearly shown in Figure 45 and Figure 46 by two crane usage graphs, one of which showed the number of lifts performed by a crane working in the oil and gas industry and the other by a crane working on offshore wind installation.

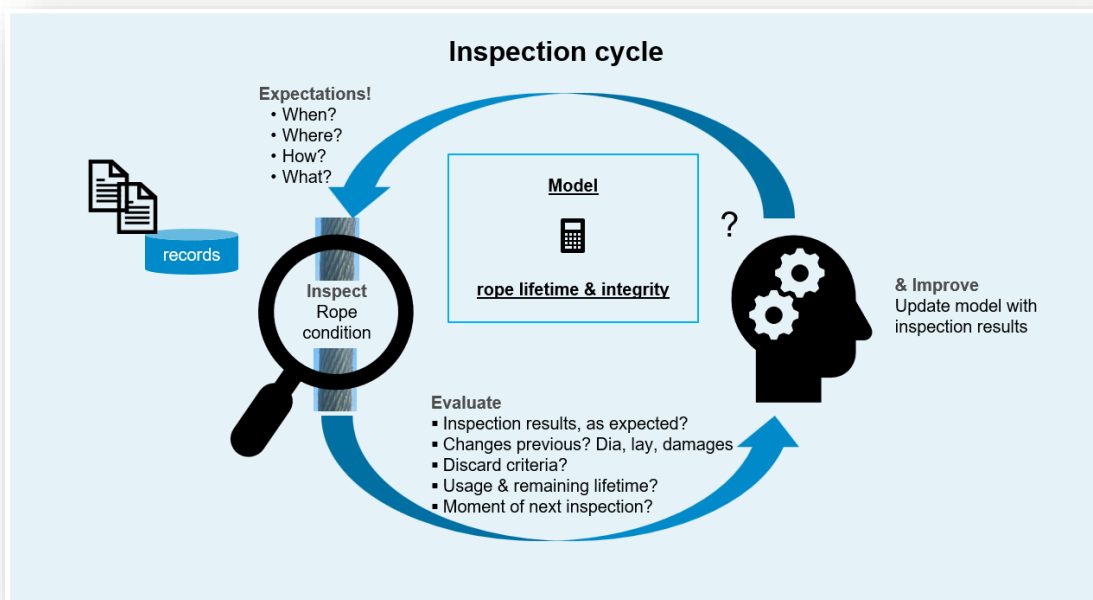
The desired rope inspection regime is shown in Figure 47 below.

Figure 47 – Desired rope inspection regime

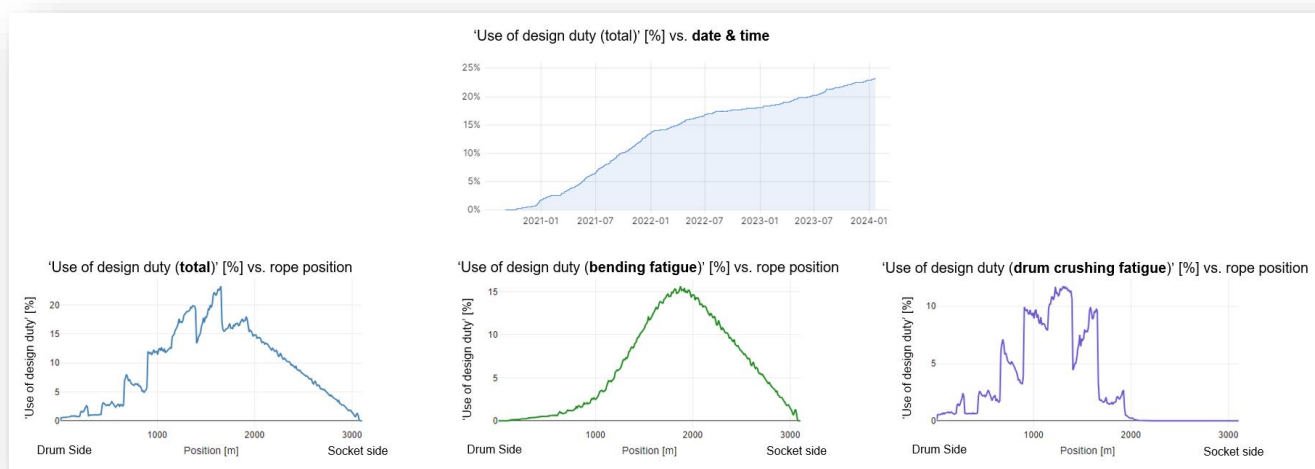
The presentation then turned to how Huisman performs rope inspection using their rope vision system and rope usage monitoring. The aim was to digitalise the information to monitor changes in condition and link them to usage. A demonstration report was shown, which comprised images of indications every 100 m, use of design duty versus rope position, and diameter versus rope position.

Figure 48 – Rope Usage Monitoring (RUM)

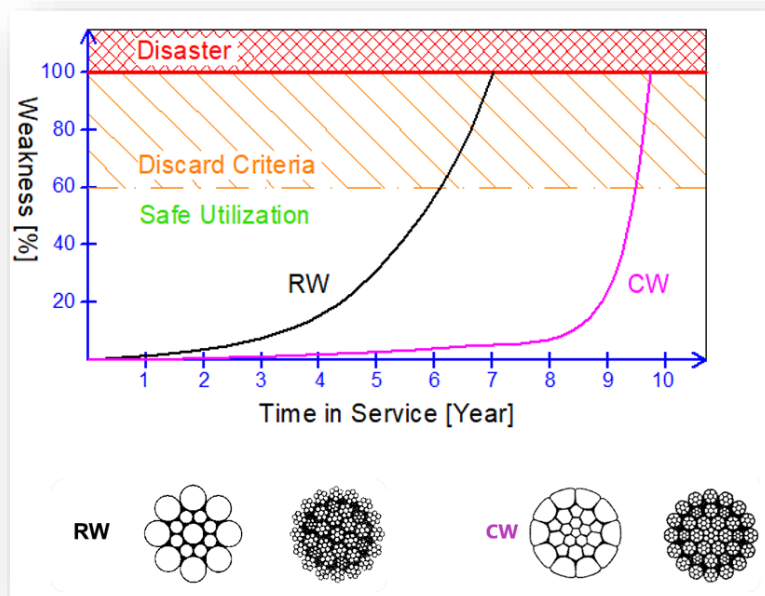
It was noted that the fatigued broken wires significantly threaten the safety of crane wire ropes. The symptoms of fatigue related to rope construction were presented using round wires in strands (RW) and compacted strands (CW). With the RW, there was a noticeable increase in the number of fatigue broken wires throughout the service life, and with the CW, there was a long service life with no signs of wear. The rapid growth of the number of fatigued broken wires in the final period of service. The graph shown in Figure 51 illustrates this.

Figure 51 – Fatigue related to wire rope construction

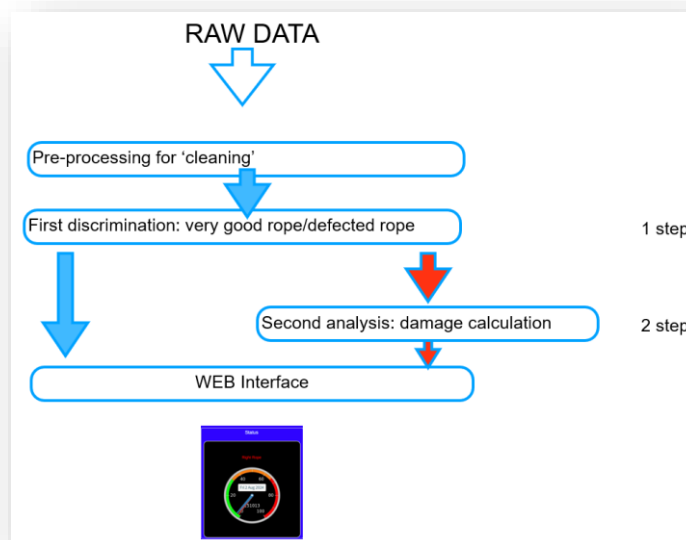
The explanation of how the raw data was processed and transformed into a gauge signal was described.

Figure 54 – Data processing to gauge visual

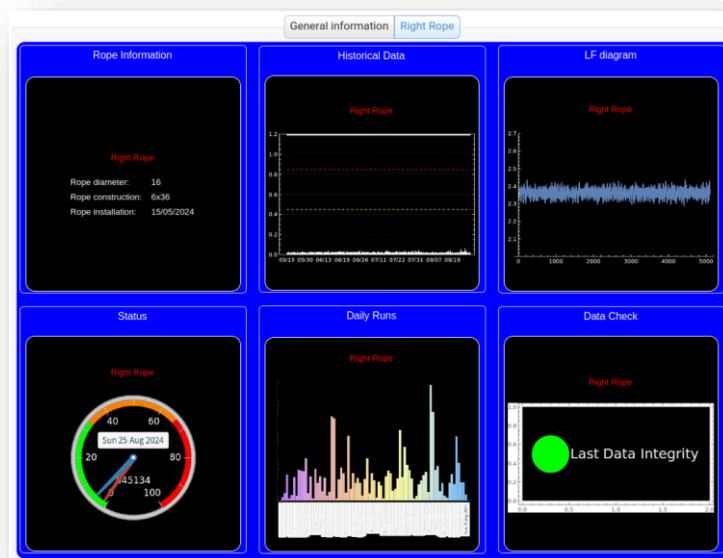
Figure 55 – Typical user dashboard

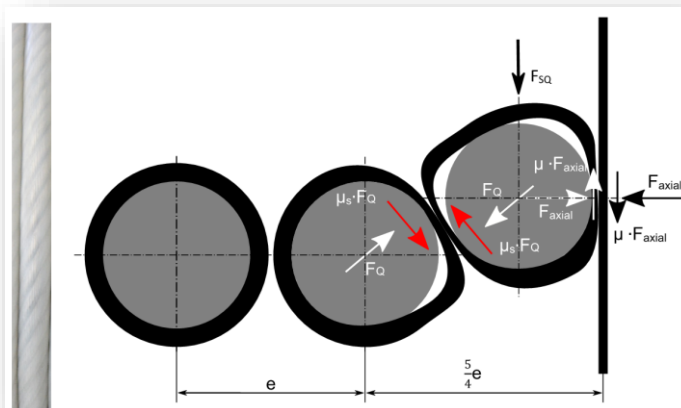
Figure 60 – Deformation during ascending winding
