## Understanding mooring incidents

*Major accidents involving mooring equipment in the last 20 years have injured many seafarers and have cost the UK Club over US\$34 million*

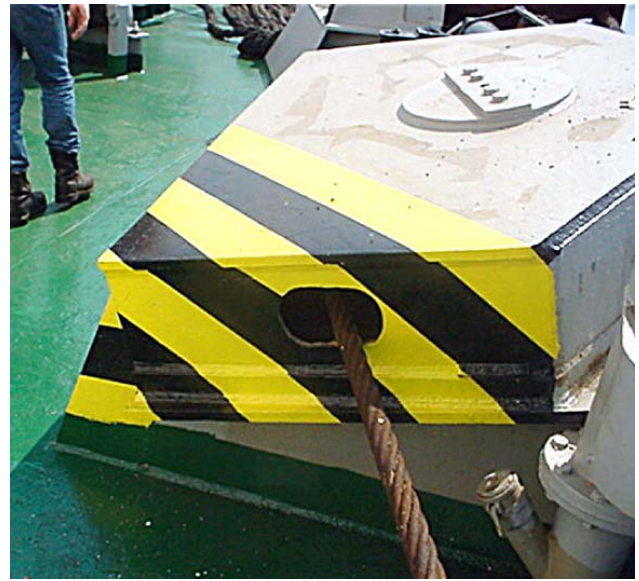
Two seafarers killed when struck by a parting mooring line

Crewmember in coma – struck on the head by a parting mooring line

3/O sustained 90% partial amputation of leg and fractured elbow

A/B suffered a fractured hip when struck by a parting mooring line

Both legs broken when struck by a parting mooring line

Mooring line slipped from windlass drum and struck crewmember's head

C/O killed when tow-line to barge parted and snapped back

Deck cadet suffered serious arm injuries during mooring operations

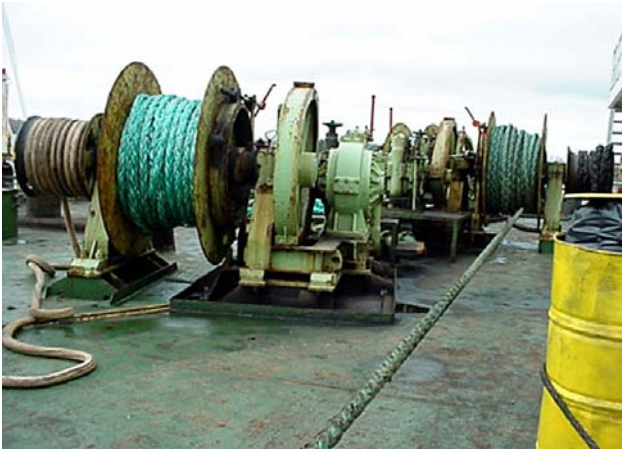
Unfortunately this photo illustrates a sight sometimes experienced by the UK Club ship inspectors. Not only are the windlasses rusty and poorly maintained, but the mooring area as a whole suggests poor safety and maintenance standards on board:

- The mooring area is dirty and all surfaces are in need of maintenance.
- All surfaces are painted the same colour, hiding trip hazards such as save-alls, windlass platforms, forecandle access hatch and bits.
- There are no hazard highlightings or warning markings.

Highlighting hazards is particularly important for the safety of crew that are new to the vessel, cadets and other trainees, and visitors. It is also important for the benefit of experienced crew who easily become complacent, tired, or too busy in their work to not notice a hazardous situation developing.

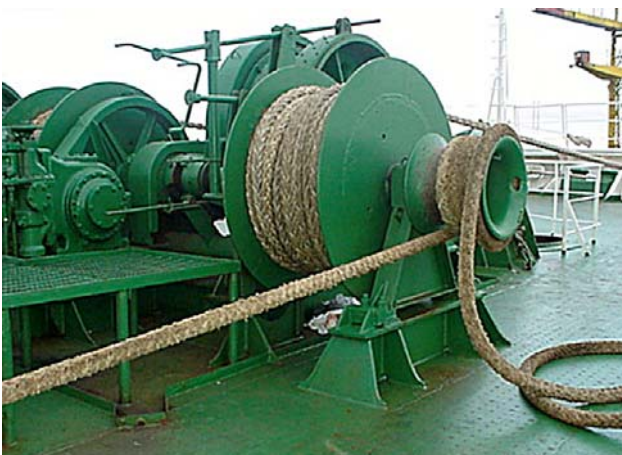
Well painted but poorly highlighted mooring station

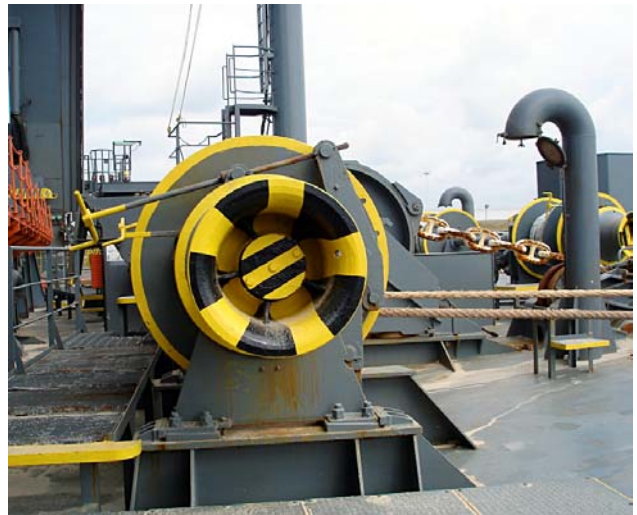
Mooring station with effective hazard markings

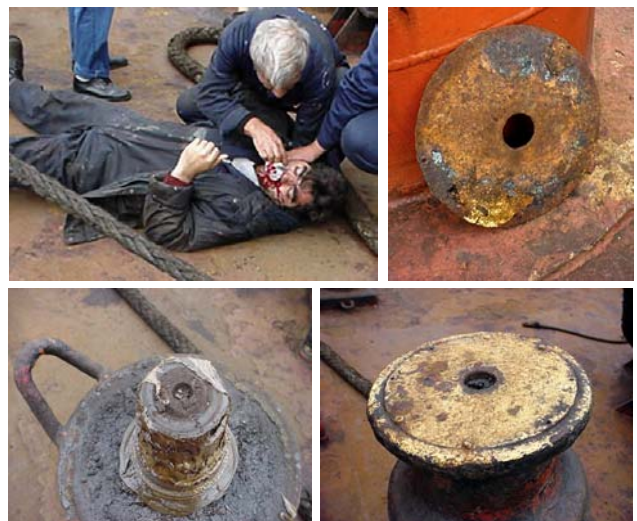
An A/B was seriously hurt when a roller fairlead detached from its pedestal whilst under the influence of a mooring line under tension. The A/B was standing in the snap-back zone and was struck by the rope, which hurled him into the foremast causing head injuries.

The rope hurled the roller fairlead 20 feet from the ship to the quayside.

The angle or directional lead of a rope should be considered when using leads in order to prevent incidents like this. But this particular incident also highlights the importance of proper maintenance of mooring equipment.

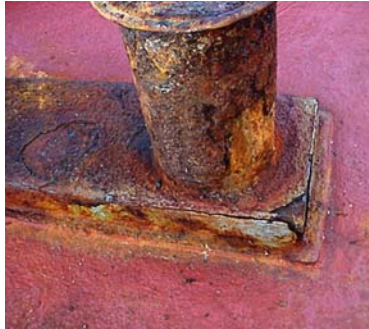
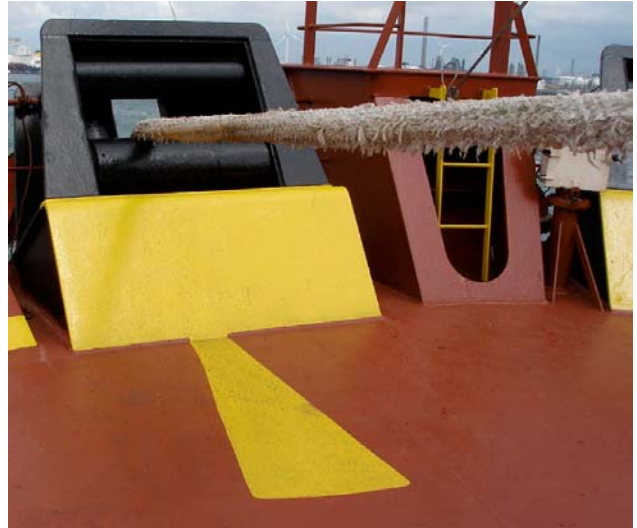
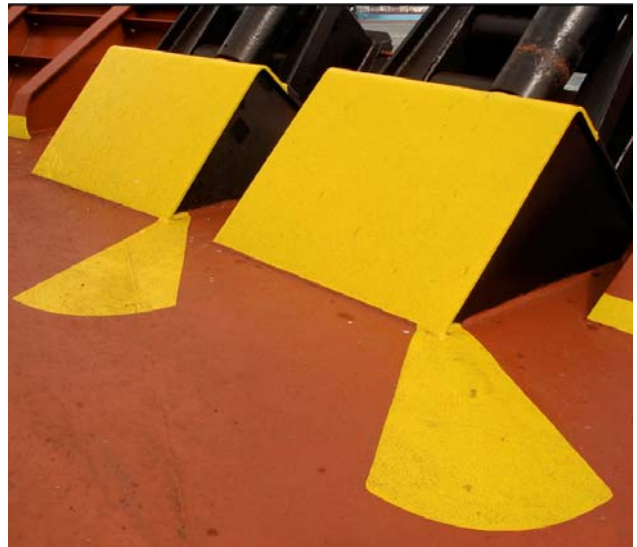
The image (left) shows a pedestal fairlead that is well maintained. There is evidence that it has recently been turned and greased and the grease nipple on top is highlighted.

Mooring equipment that has suffered severe wastage will not perform to the certified standard. This also applies to the steel to which the equipment is welded. The image shows mooring bits that are badly wasted. The deck is in equally bad condition and there is a danger of the bits being torn from the deck.

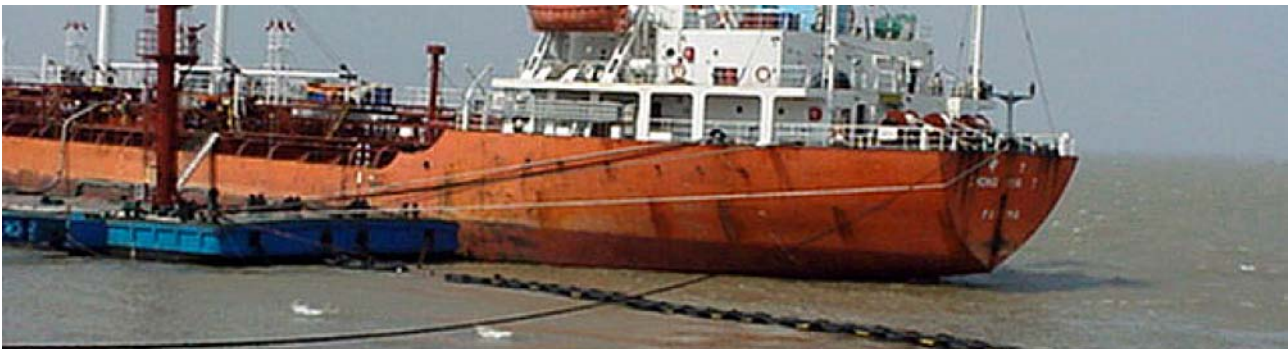
The image below shows a vessel considerably overhanging her berth. She is therefore unable to lead any stern lines aft of the ship. The image shows one line in particular being lead an extremely long distance, rendering it pretty much useless.

The ship has correctly put out as many lines as possible but should also consider the use of the anchor and mooring lines running aft from either the main deck or other suitable areas. In situations like this it is important to analyse local tidal and weather patterns in order to predict how the vessel will be affected. The vessel owners should be informed and cargo operations stopped (or not commenced) if conditions do not appear safe.

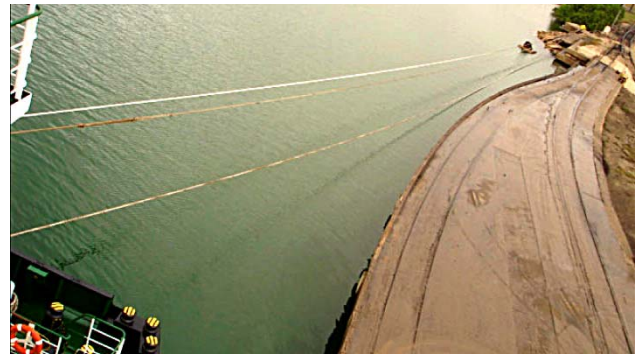
The following image shows insufficient mooring arrangements ashore and the vessel is forced to pay out an extremely long lead on the stern lines. In this event, the master should protest to the port authority, take photos and inform the owners.

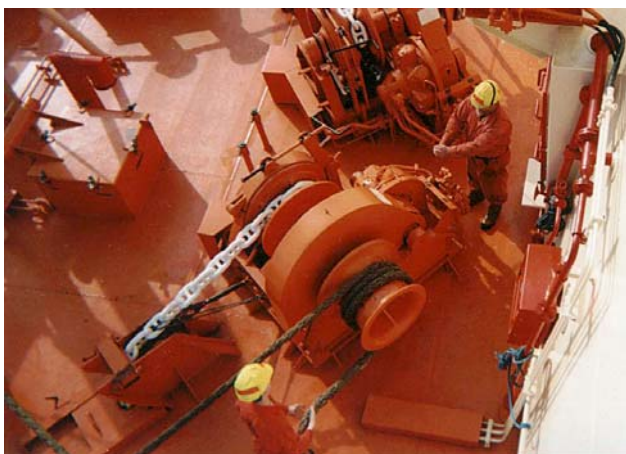
Mooring operations should be conducted in a safe manner. In the image below:

- The line on the windlass drum is being handled safely. The crewmember at the drum is keeping his hands clear of the turns and positioned so as not to become fouled in coils of rope.
- The crewmember operating the windlass has a good line of sight of the rope and the man handling it.
- Both crew are appropriately attired in correct personal protective equipment.

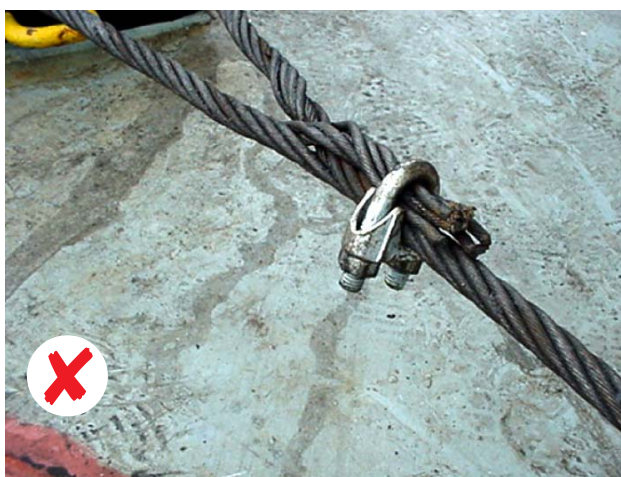
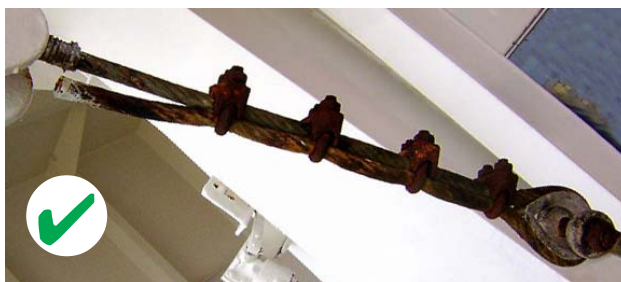
- An allowance of 150 mm should be made between the last bulldog grip and the end of the 'dead' wire. It is important to ensure that the lashing wires are not cut short immediately next to the bulldog grips.

- Bulldog grips have a grooved surface in the bridge piece which is suitable for a standard wire of right-hand lay having six strands. Crosby grips have a smooth surface in the bridge piece. The grips should not be used with ropes of left-hand lay or of different construction.
- The first grip should be applied close to the thimble or at the neck of the eye if a thimble is not used.

Other grips should be placed at intervals of at least one clear grip (albeit a distance of six rope diameters apart is suggested) between each other.

- The grips must all face in the same direction and must be fitted with the saddle or bridge applied to the working or hauling part of the rope. The U-bolt must be applied to the tail or dead-end of the rope. If the grips are not applied as indicated above, the effectiveness of the eye can be seriously affected.

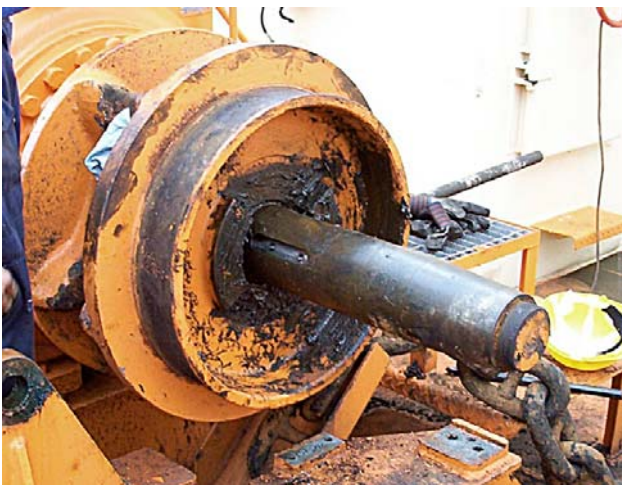
Windlass drums are not designed for taking the weight of mooring lines for a long period of time. If windlass drums are used for this purpose then over a period of time they will suffer damage and be in need of repair.

**This windlass drum suffered bearing damage and is being overhauled**

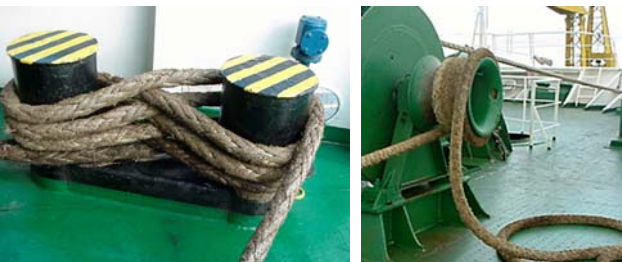
**Once ropes have been hauled tight they should be secured to bitts as in the good example on the left**

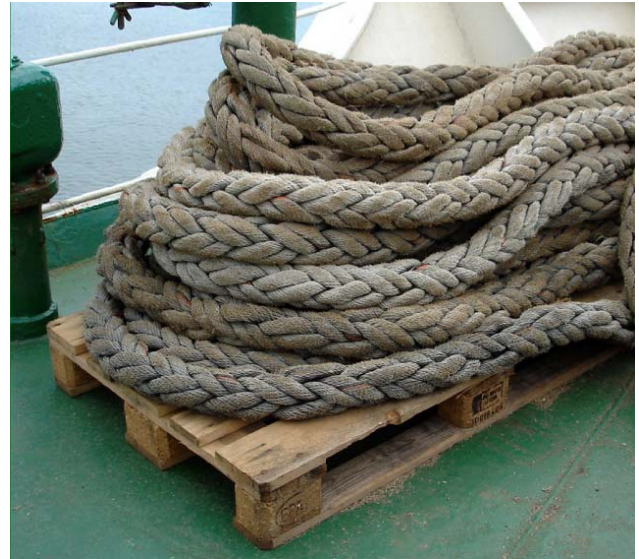
**Ropes correctly stowed off deck**

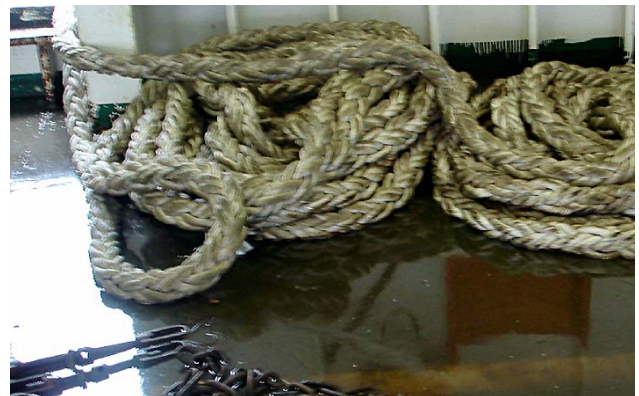
**Ropes badly stored on wet deck**
