8 Pilot Ladder Failure

Marine Safety Forum – Safety Flash 11-29

Subject: PILOT LADDER INCIDENT IN ABERDEEN BAY

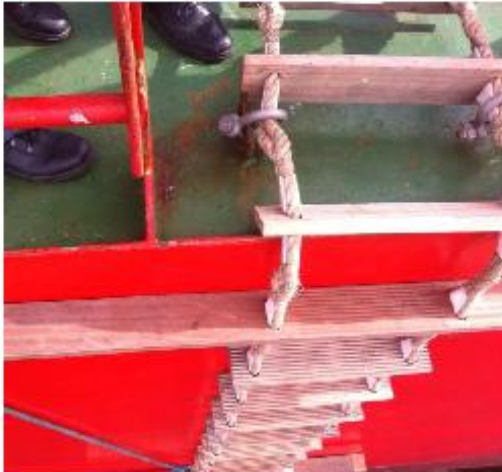
- The pilot ladder was in poor condition and the pilot ladder ropes were worn by contact with the sheerstrake.
- There were no measures in place to reduce the effect of the sharp edge of the vessel's sheerstrake on the pilot ladder ropes.
- The wear on the pilot ladder ropes from contact with the sheerstrake was not considered as the company risk assessment process was not effectively implemented on board.
- Experience Transfer highlighting the potential hazard from the deployment of a pilot ladder over the sheerstrake was not yet issued to the fleet.
- The pilot ladder was stowed on the open deck by the pilot boarding station and was not covered and suffered deterioration from the weather.

Pilot Ladder Deployed Over Sheerstrake

1. Any sharp edges with the potential to affect pilot ladders to be removed
2. A new and unused spare pilot ladder to be provided
3. Gratings to be installed to raise pilot ladders from deck (if not stored in a dry and clean environment)
