## 1 Structural failure of rescue boat

## 2 High potential: spontaneous opening of Hydraulic Release Shackle (HRS) pin

**3 NTSB: Diesel Generator Engine Failure**

## 4 LTI: fall from height during anchor chain handling operation

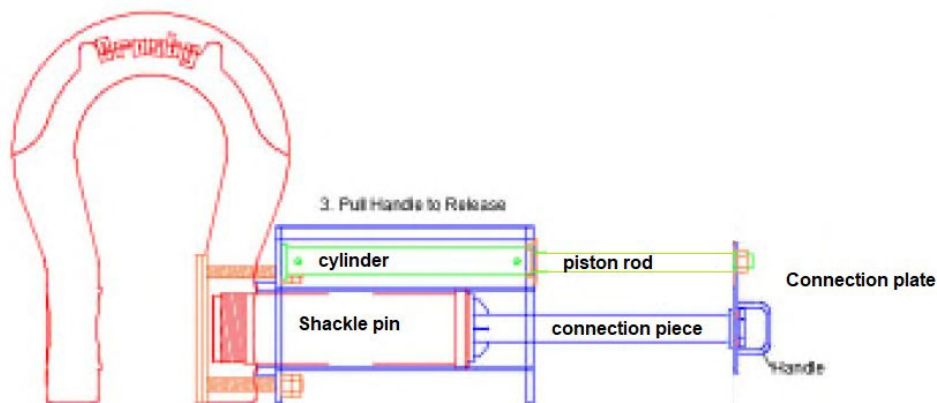
*Diagram of the Hydraulic Shackle set-up*

After rigging back the 'blue shackle' to its position and performing function tests to this same shackle and the other 3 HRS units, it was then identified that the 'yellow colour coded' HRS was damaged (broken piston) and further damage was identified to the initial 'blue colour coded' HRS (bent piston rod). The operation was subsequently abandoned.

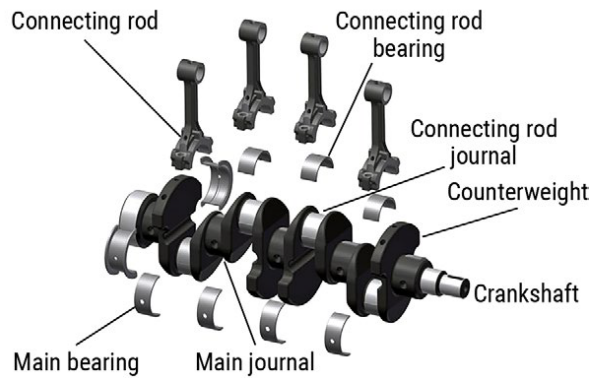
*Typical components of a diesel engine crankshaft*

During the maintenance period, service technicians identified a standard-sized connecting rod bearing on the no. 3 main engine that did not meet the service company's specifications and, in accordance with their policy, replaced all the connecting rod bearings with standard-sized bearings. They also removed and inspected the no. 6 main bearing, which, unbeknownst to them, was undersized with a smaller inner diameter.

Because none of the connecting rod bearings they replaced had been machined, the technicians used standard-sized bearings to replace the no. 6 main bearing, since it was the service company's expectation that both main bearing journals and connecting rod bearing journals would be machined at the same time. There was no record of the main bearing's part number in the service technician's notes; therefore, the technician likely did not identify and record the part number. The service company's standard practice was to replace any removed bearings with new bearings, so a new standard-sized bearing was ordered and installed.

Investigation revealed that the probable cause of the mechanical failure of the no. 3 main engine and resulting fire was the replacement of a crankshaft main bearing with an incorrectly sized bearing during a previous engine overhaul. Engine service technicians did not correctly identify the removed bearing's part number, which resulted in the loss of lube oil pressure in adjacent connecting rod bearings.

When maintenance is performed, correct replacement of machinery components is critical to ensuring safe and reliable vessel operation. Vessel crews and equipment manufacturer technicians should carefully identify and document part numbers of all components removed from shipboard equipment. Tracking systems are an effective form of record-keeping that can be used to ensure proper replacement part selection for reinstallation.

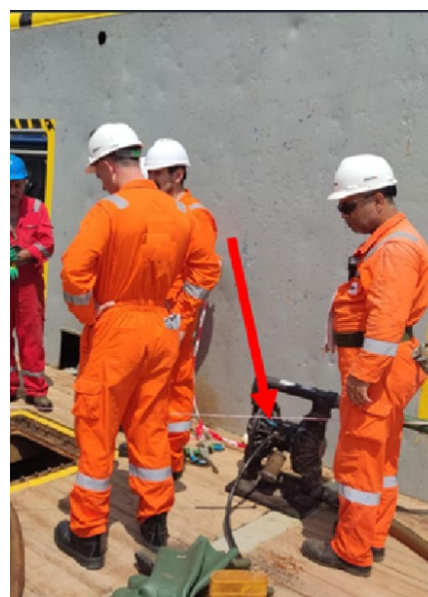
*Showing pump*
