1 LTI: Finger injury during emergency recovery of ROV

2 BSEE: recurring hand injuries from alternative cutting devices

3 Hot work performed outside of Permit to Work (PTW) boundary limit

5 NTSB: Crane wire failure

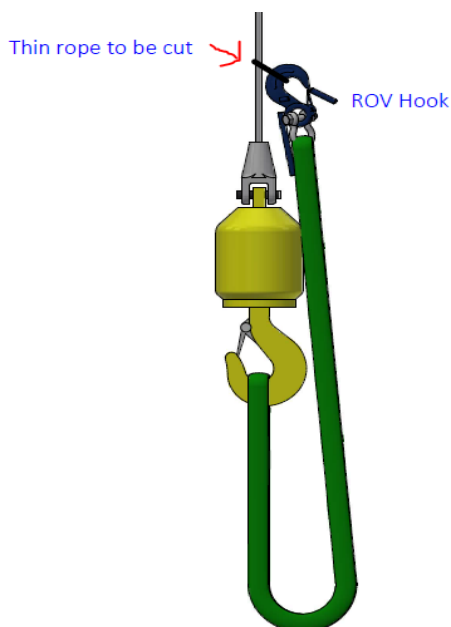
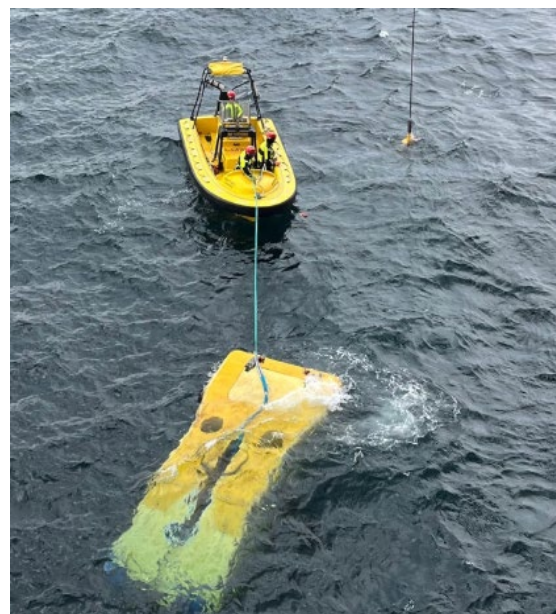
A worker suffered a serious finger injury when their finger was caught between a crane wire and the recovery hook on an ROV. The incident occurred during an emergency recovery of the ROV. A small boat (an FRC) was used to facilitate connecting the ROV emergency rigging sling to the crane hook to allow recovery of the ROV to deck. Movement of the crane headache ball was controlled by having it slightly submerged and having the forerunner with ROV hook tied up with a rope to the crane wire.

The worker successfully retrieved the emergency rigging on the ROV and attached it to the FRC by a securing rope. Then the FRC moved away from the vessel and the crane operator on the vessel started paying out wire and manoeuvring the rigging towards the FRC. However, before retrieving the crane hook, the worker had to release the ROV hook attached to the crane wire with a thin rope, using a knife. As the worker did so, their finger was pinched, resulting in an amputation down to approximately the nail bed on the left ring finger.

- The step of releasing the ROV hook from the crane wire was not identified as a step, hence it was neither planned for nor risk assessed;
- Once the emergency recovery had started, the steps that needed to be taken were not sufficiently detailed in the plan or procedure;
- Fault finding and repair of latching mechanism on LARS ought to have been attempted prior to emergency recovery.

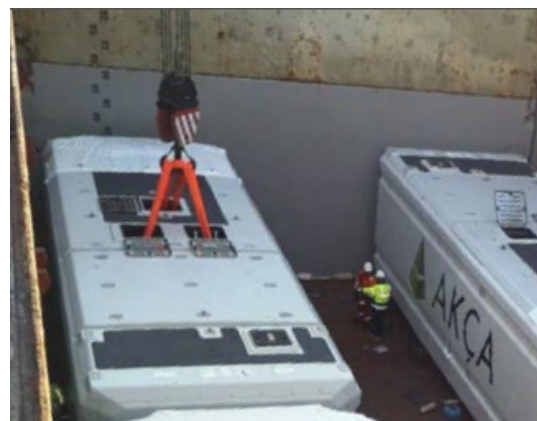
Similar nacelle in another vessel’s cargo hold rigged in accordance with manufacturer-recommended guidance.

roughness and pitting, and “uniform corrosion of internal surfaces” of the hoisting wire rope. This corrosion and wear caused some of the individual wires comprising the strands of the hoisting wire rope to part when the crane lifted the nacelle unit, subsequently causing the strand and then the remaining wire strands to become overloaded and fail.
