# **Safety Alert**

**ALERT 15 - 04**

## FINGER INJURY LEADS TO LTI

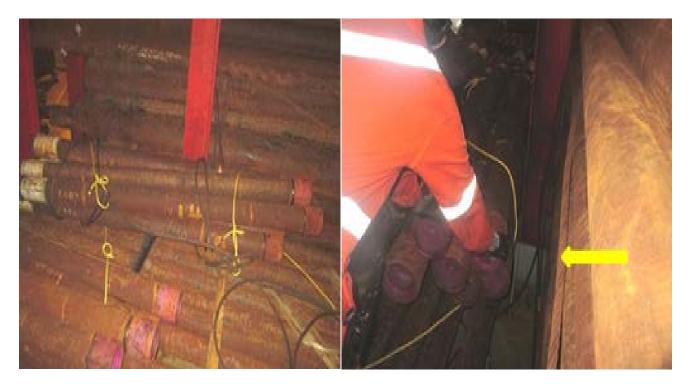
Roustabout was requested to assist on a cargo handling operation from the Main Deck. The task was to connect the crane hook to the slings of a pup joint bundle. The bundle was to be sent over to a platform with the use of the crane. When the Roustabout, who was working on his own, signaled to the Crane Operator to pick up the load, movement of the rig allowed the bundle of pup joints to sway in the direction of the Roustabout and he pinched his right hand between two joints, thus injuring two fingers in the process. After receiving X-rays it was diagnosed that both fingers had sustained fractures.

- Standing too close to the load as it was hoisting.
- Using Team Member that was not originally part of the task
- Failure to use taglines and/or push poles to control the load
- Failure to follow the correct rigging and lifting techniques by using only one man for the job.
- Failing to think about the risks involved.
- · Not utilizing the stop work authority.

- No job is so important that we cannot take the time to do it safely.
- A JHA for the task should have been completed and discussed with crew.
- Team Members to stand clear of load while hoisted and using proper taglines and handling tools
- Supervisors to understand situational changes.
- Use safety interventions such as Step back 5 x 5 and the Stop Work Authority when required.
- Time to be taken to have correct amount of people to do the job at all times.
